Leaky Topper Upper Mast?

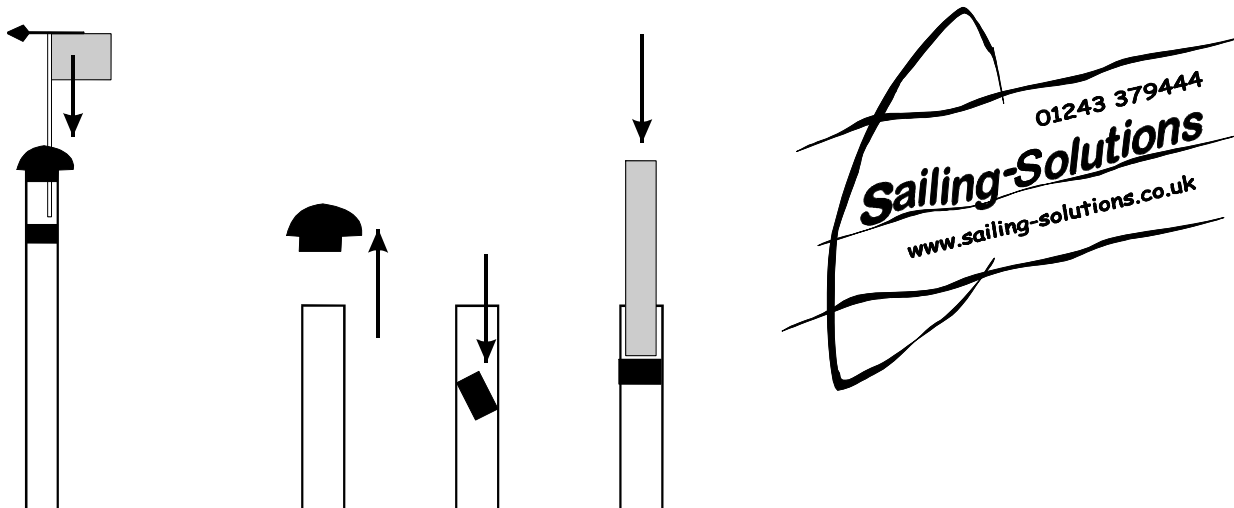
Topper upper masts are designed to be sealed floatation chambers that slow down a complete inversion in the event of a capsize. They work ok when empty but really make things difficult when they are full of water! Apart from speeding up the inevitable full inversion, once capsized, they increase the likelihood of a capsize by weighing the rig down and they make the boat pitch badly in any waves at all. There are two seals/bungs, one inside the bottom of the upper mast and one underneath the masthead crane at the top of the upper mast.

The 'bungs' are a push fit and generally work fine but once disturbed they need re-seating. Pushing the burgee in too far will cause the bung to either puncture or to be twisted.

See diagrams above:

- Remove the masthead crane by drilling out the rivet and carefully driving it out (a gentle tap on the front and then the back repeatedly is the best way).
- Drive the old bung sideways and either hook out or leave twisted but drive further in.
- Drive the replacement bung in square with a wooden stake of the right diameter (ish!). There is a lip on the bung, which does the sealing - it will go! Use a little lubricant if necessary; washing-up liquid is good. Some people use a sealant as well but I have not found this necessary.
- Do the same to the lower bung.
- Replace the crane
